### **FATAL ACCIDENT REPORT**

## **WEBSTER COUNTY COAL, LLC DOTIKI MINE**

**ROOF FALL**

**STATE FILE No. 08987**

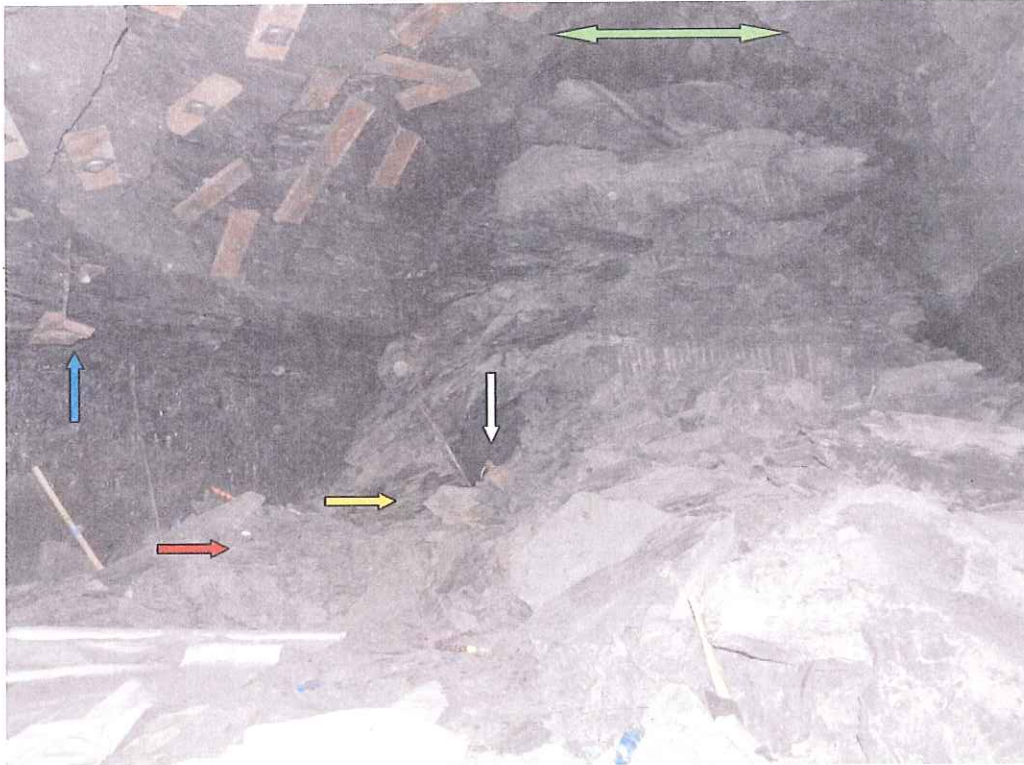
**ACCIDENT SCENE  
NO. 6 UNIT - NO. 3 ENTRY**

**RED ARROW INDICATES THE APPROXIMATE LOCATION OF MICHAEL CARTER  
(UNDERNEATH THE ROCK)**

**YELLOW ARROW INDICATES THE APPROXIMATE LOCATION OF JUSTIN W. TRAVIS  
(UNDERNEATH THE ROCK)**

**WHITE ARROW INDICATES THE CORNER OF THE CONTINUOUS MINER  
(UNDER THE ROOF FALL)**

**GREEN ARROW INDICATES THE TOP OF THE ROOF CAVITY  
FROM WHERE THE ROCK FELL**

**BLUE ARROW INDICATES THE LAST UNDISTURBED PERMANENT ROOF BOLTS -  
THE OTHER ROOF BOLTS WERE INSTALLED DURING THE RECOVERY EFFORT**

There were six (6) individual slickensides (slips) visible in the roof cavity above the fall. The slips were oriented at various dip angles from near vertical to flat. According to testimony, none of the slips were visible in the roof when the entry was developed. However, slips had been reported in one entry, according to the on-shift – pre-shift mine examiner's report, for the No. 6 unit, dated April 28, 2010; there was a slip reported in the No. 0 entry and adverse top in the No. 6 entry. Also, in the remark section was a statement about scaled loose rock across the section.

There were six (6) individual slickensides (slips) present in the mine roof at locations ranging from approximately seven feet (7') to ten feet (10') above the coal bed. The slickensides were at various dip angles and were randomly oriented. None of the slickensides extended through the immediate roof above the coal bed. Statements from mine personnel indicate that due to the location of the slickensides, they were not detected during examinations.

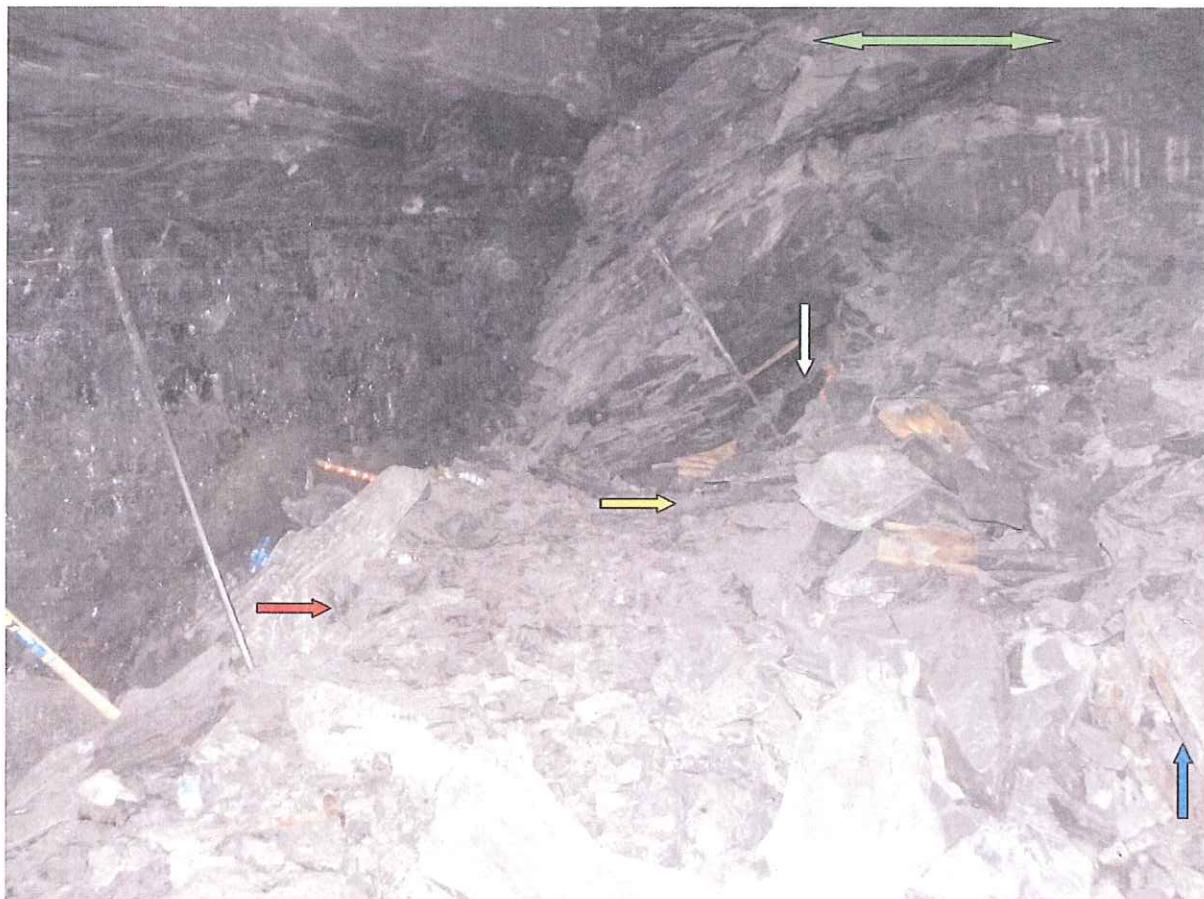
**ACCIDENT SCENE  
NO. 6 UNIT – NO. 3 ENTRY**

**RED ARROW INDICATES THE APPROXIMATE LOCATION OF MICHAEL CARTER  
(UNDERNEATH THE ROCK)**

**YELLOW ARROW INDICATES THE APPROXIMATE LOCATION OF JUSTIN W. TRAVIS  
(UNDERNEATH THE ROCK)**

**WHITE ARROW INDICATES THE CORNER OF THE CONTINUOUS MINER  
(UNDER THE ROOF FALL)**

**GREEN ARROW INDICATES THE ROOF FALL**

**BLUE ARROW INDICATES THE CONVEYOR BOOM OF THE CONTINUOUS MINER  
WHICH WAS COVERED BY FALLEN ROCK**
